## **Towards effective Hydrological Measurements downstream of Oyan dam**

Olatunji T.

National Water Resources Institute, PMB 2309, Kaduna, Nigeria.

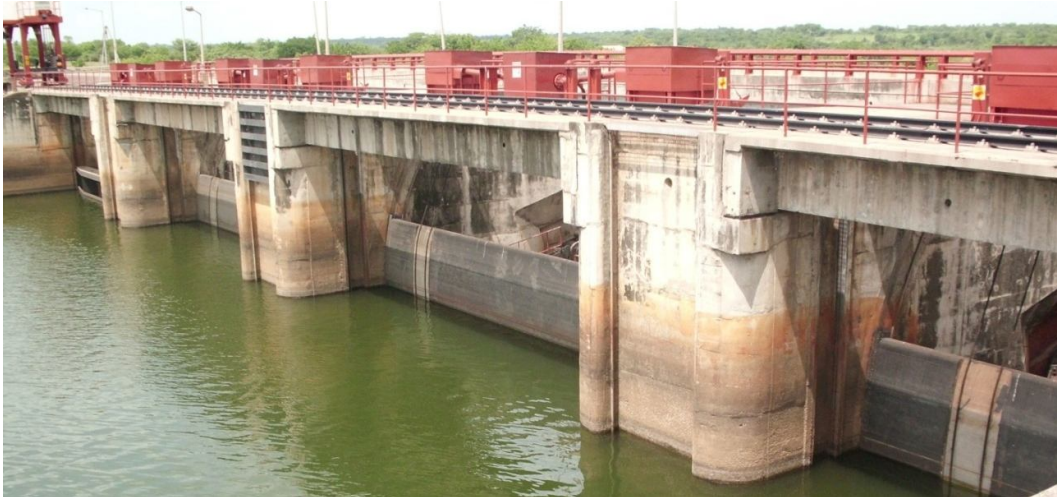
Figure 3: Spillway section at Oyan dam.

The Bench mark at the security gate of Oyan dam is located at 31 N 0528592 , E 0802661. The dam site elevation at this Bench mark was 85 m above mean sea level. Reservoir water level as at the time of visit at the Dam was 60.3 m. The downstream channel at the dam site was filled with water hyacinth and rock outcrops. The downstream flow was at the mercy of

the dam reservoir releases controlled by four (4) functional radial gates (Figure 3). Greenish vegetation was observed around the dam. The dam site was accessible but there was no suitable point for measurement along the river course before Alamutu Village. Upstream of the dam, land use activity was observed at left bank, while on the right bank evidence of some work done on a proposed irrigation scheme was noticeable.

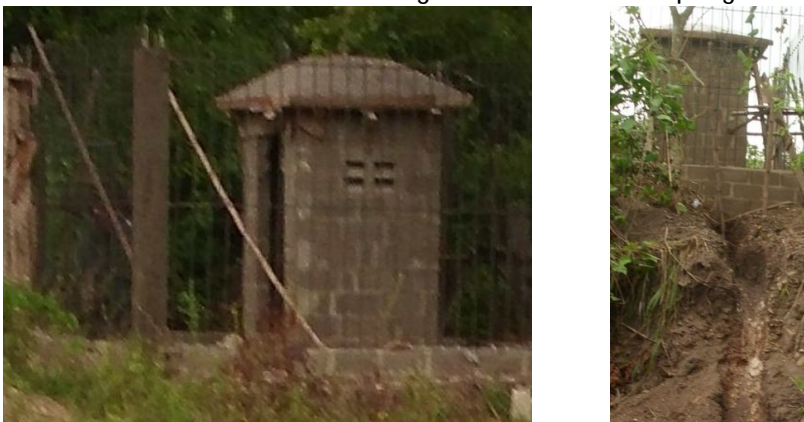
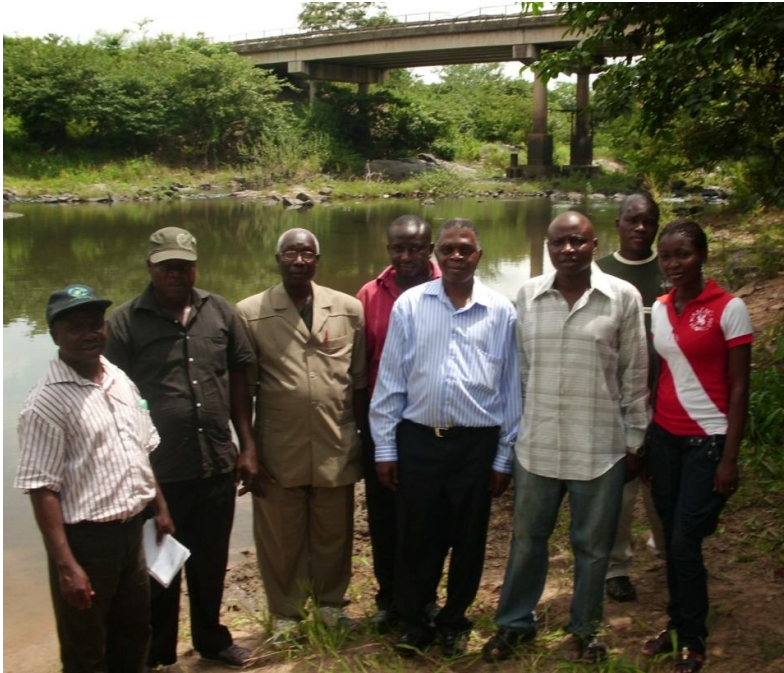
Here, the construction of housing for equipment on Early Flood Warning System was on-going (Figures 4 and 5). The elevation observed at this site (near the bridge on Abeokuta – Sokoto road) was 48 m. GPS positioning was (31 N 0532756 , E 0797800 ) Rock outcrops was observed within the channel. There was no existing hydrological station to record water level and none was being proposed, which if done may complement downstream observation. It was observed that the floodplain was very steep and soil surface bare, which may encourage soil erosion vis-à-vis sediment inflow to the river channel. It was discovered that installation of a new hydro station was being proposed by the OORBDA. The site was accessible and suitable for discharge and sediment sampling measurement.

Figure 4: Early Flood warning equipment housing under construction

Figure 5: Downstream Study Group at Oyan river below Early Flood warning equipment housing.

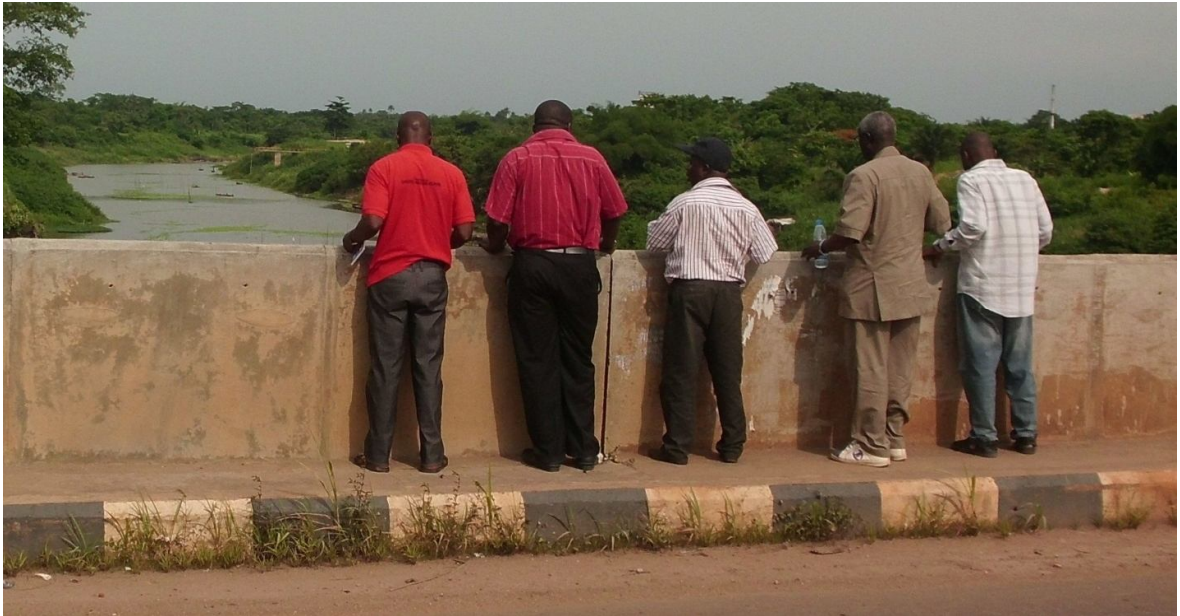
On a side of the bridge railings, the GPS positioning are (31 N 0541285, E 0760610) at an elevation 23 m. An ungated rectangular weir (Figure 6) with auxillary side channel spillway was built on the river channel. Sandy bed was observed downstream of the bridge with attendant on-going sand mining activity both on the river channel and the floodplain. The ingenious miners created some secondary currents in the river by putting some obstructions under the bridge. This arrangement constrained the flow to go forward and turn back in a section of the river. In the process of turning back, the velocity reduces and more sediment settles in the river bed increasing the available sand to be mined. The reservoir behind the weir and the channel was infested with water hyacinth. Floodplain was dotted with green vegetation such as trees, plantain plantation and palm trees. There was no water level recorder at this site. Floodplain soil characteristic was clayey in nature, which could encourage mud turbidity during high runoff. Site accessibility was okay but would required bush clearing during the project execution. The site was suitable for measurement at downstream or upstream of the weir.

Figure 6: River Ogun at the bridge close to Mokoliki weir.

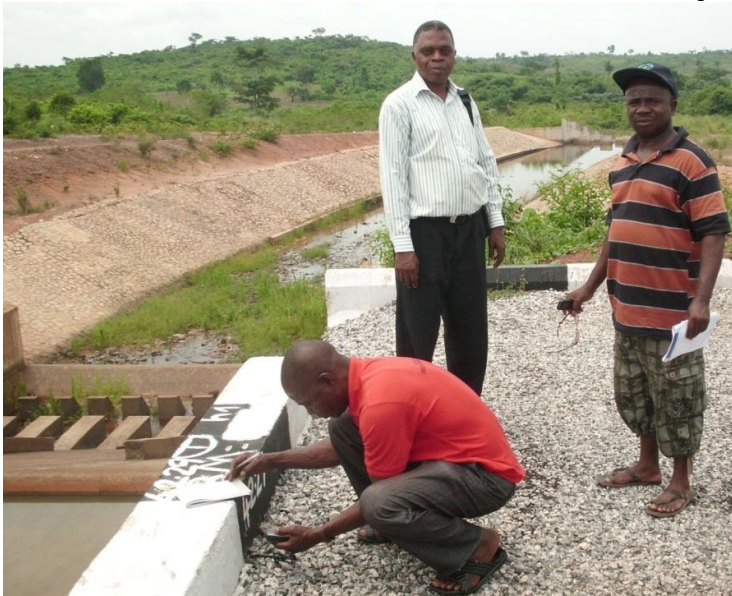
Figure 7: Spilway section of Owiwi dam

River Owiwi is a tributary of Ogun River. At Owiwi dam site (Figure 7), the study group visited water treatment site which supplies water to Owiwi communities and settlements near Abeokuta. The owiwi reservoir irrigates about 45 ha of land. Water level at the time of visit was 38.6 m. Bench mark was at 42.29 m. GPS readings were 31 N 0529551 , 0780599

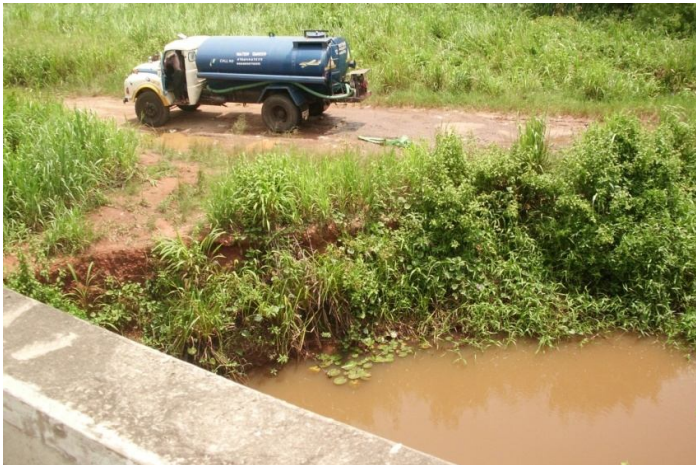
The site is shown in Figure 8. . At this site accessibility was okay but the river width was very narrow. It was envisaged that suitable location for measurement could be found a little

further down of the bridge. No gauging station was seen, but BM of Owiwi dam site could be transferred to this site. The river channel was bushy and needed clearing. GPS readings were 31 N 0530874, 0779546, with an elevation of 40 m

Figure 8: River Owiwi at the bridge on Abeokuta – Lagos road

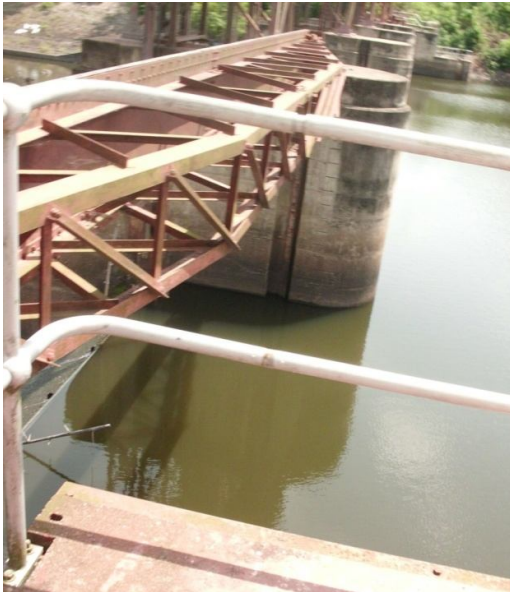
Iberekodo Water works was established in 1962 and equipped with five (5) vertical gates (Figure 9), supplying water to Abeokuta metropolis and its environs. Water level of reservoir as at the time of visit was 5.27 m. However, the visiting team was informed that the minimum operating tolerable level is 4.27 m. Anything below this level would hinder the water supply regimentation. This rather informed the frequent complaints of Lagos community of inadequate raw water supply at this critical water level at Iberekodo Waterworks. The channel downstream was dotted with rock outcrops which may hinder discharge measurement. Discharge measurements could be done further downstream or upstream of the waterworks. GPS readings were 31 N 0536617, 0794632 at an elevation of 48 m.

Figure 9: Weir at Iberekodo waterworks in Abeokuta
