Assessment of Urban Flood Disaster: A Case Study of 2011 Ibadan Floods

Land and Water Division
National Water Resources Institute, Mando Road. Kaduna

Special Publication of the Nigerian Association of Hydrological Sciences, 2012

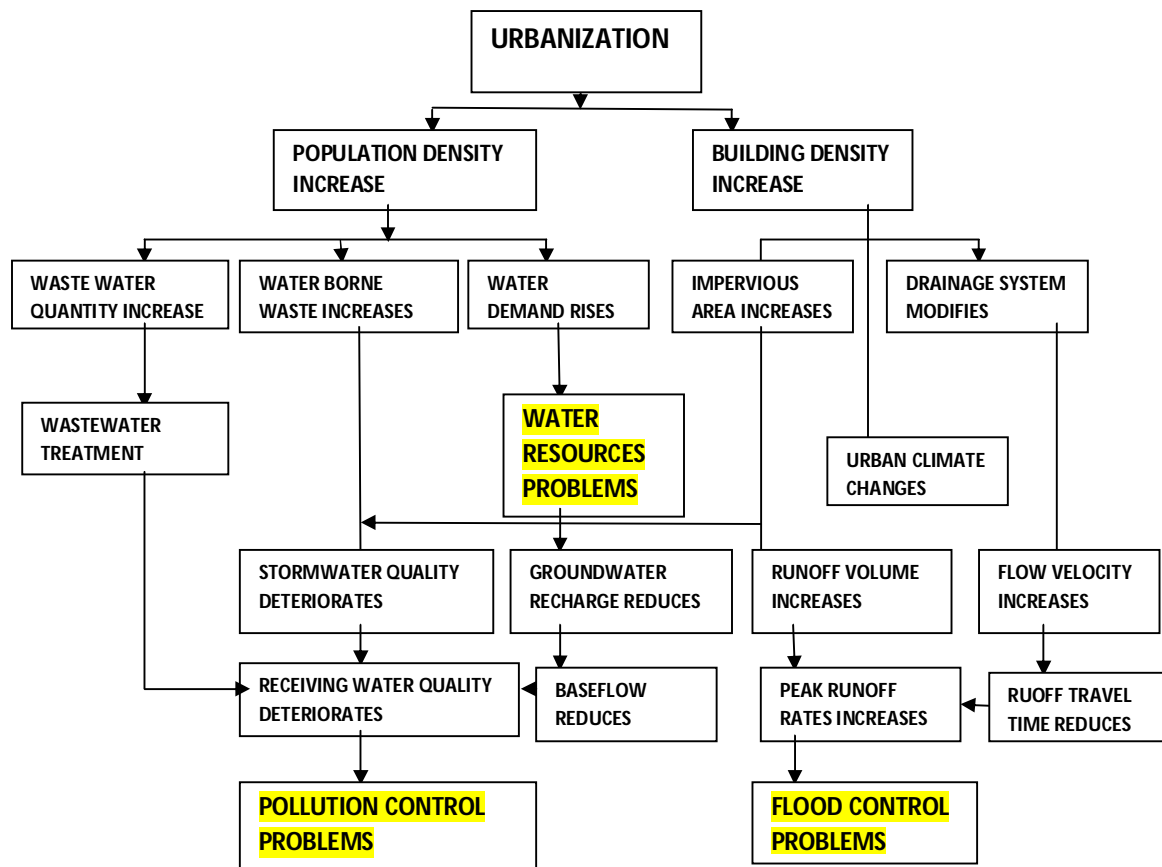
Fig. 1: Hydrological impacts of urbanization (Andjelkovic, 2001)

Urbanization lead to increase in population and associated construction of houses and infrastructural development reduces areas for natural infiltration of storm waters while paved surfaces are increased. Common feature of urban development in the developing countries are property development in the floodplains and indiscriminate dumping of solid natural and artificial channels which reduces the carrying capacities of the stormwater channels and increase the risks of urban flooding. Urban flooding arises when the urban stormwater channels capacities are overwhelmed by stormwaters generated from rainfall and spills into adjoining properties which are inundated throughout the period the conditions are sustained. Associated consequences include disruption of social-economic activities, utility supplies, communication, transportation, loss of properties and human lives. The flowchart presented in figure 1 explains the processes of urban floods and its consequences.

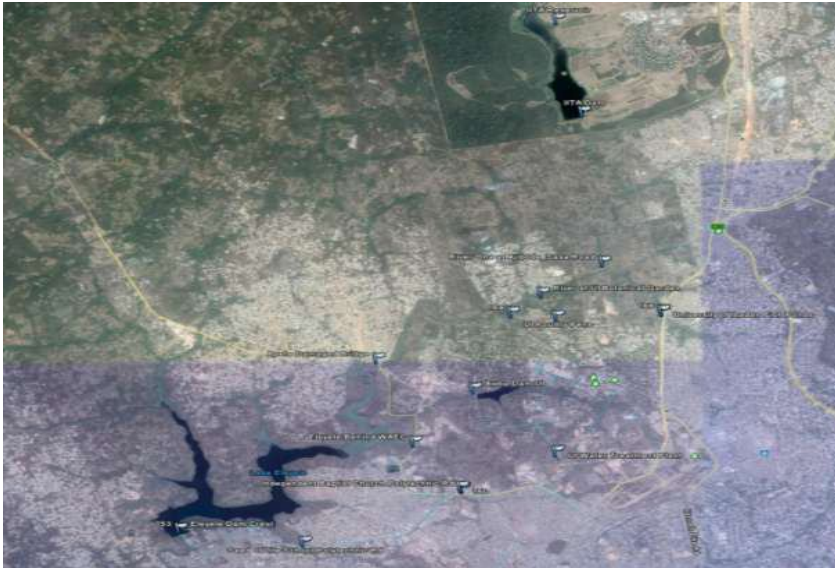
Fig. 2: The three Reservoirs within Study Area. (Google Earth, 2011)

The Ona River and its tributaries drain the western and the northern part of the City in a south western direction. The Awba River a major tributary of the Ona River took its source around Moniya, upstream of the IITA. The IITA dam was constructed on the Awba River in 1967 and provides a dependable source of agricultural and domestic water supply for the entire Research Institute. The Ona River took its source around Bodija, a highly built up elite settlement and flows through Agbowo into the University of Ibadan (UI) where another tributary, Orogun River which drains the Ojoo Area discharges into the Ona River upstream of the confluence of Awba River and Ona River at Ajibode-Sassa road, immediately upstream of the UI Botanical gardens. The UI dam was constructed on a tributary of the Ona River which has its headwaters at Sango. The main Ona River channel was dammed at Eleyele, downstream of the IITA and UI dams, a waterworks was constructed downstream of the dam and had since 1942 provided a dependable source of water supply to Ibadan, producing 37,000m³/day of treated water. Fig. 2 shows the three dams and the densely built up areas in the upper catchment of the Ona River and its tributary.

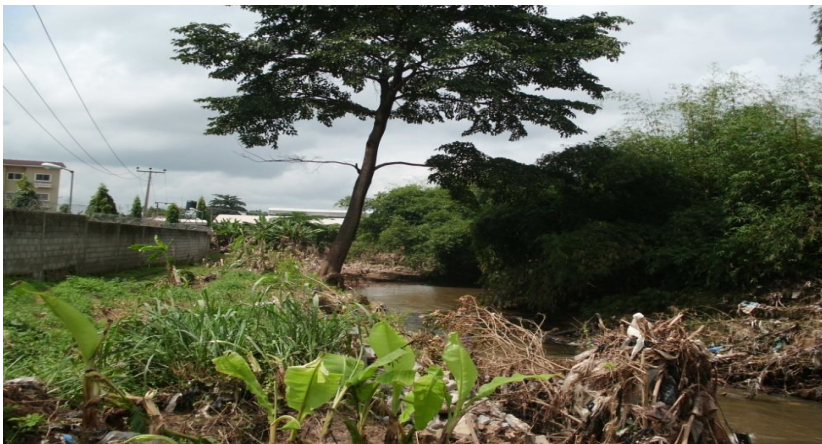
Fig. 2: Ona River Channel at Oluyole Estate Ibadan

A physical assessment of the upper reach of the river shows a significant part of the flood plain and the river channel has been encroached by housing, commercial and industrial developments. The Channel bed is characteristically flat in most reaches having lost its depth to siltation arising from silts, debris and solid wastes it carries in its flow. The hydraulic implication of this is the loss of river channel's runoff carrying capacity. Of great concern is the presence of thick vegetation comprising of bamboos, typha and elephant grasses and big trees along the river channel as it flows through the City. This help in trapping debris and volume of solid waste in the runoff thereby creating high frictional flow with attendant high time of concentration. In the event of high rainfall like the one experienced on August 26, 2011, the channel capacity easily become overwhelmed resulting in the flooding of its floodplain and adjoining properties. Figure 2 presents the situation of the Ona River Channel at Oluyole Estate.

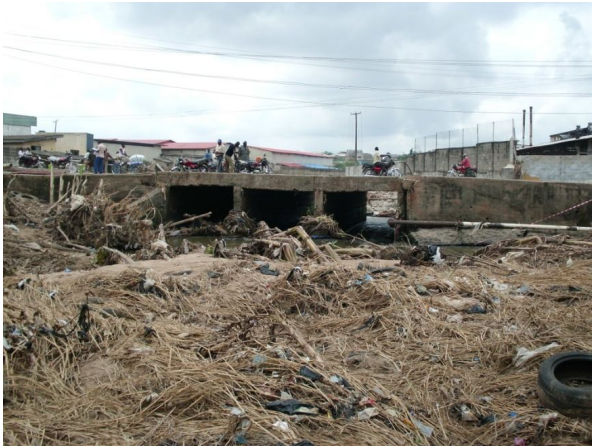
Fig. 3: Solid Waste Blockage at The Culvert Entrance at Oluyole Estate

Solid waste collection and disposal system in the City are poorly managed. According to Onibokun & Kumuyi 1999, Sangodoyin 1991, Olaseha & Sridhar 2004, Adenji & Ogundiji 2009, and Olaseha, I. O. and Sridhar, M. K. C. (2004) that the solid waste management service in Ibadan are inadequate, with a preponderant proportion of the refuse generated remaining uncollected and with large parts of the city, particularly the low-income areas, receiving little or no attention. The wastes are generally disposed in the storm drainage and river channels, constituting major friction to flow of stormwater in the channel and become trapped at bridges and culvert locations causing over spilling of flood waters at such locations. Figure 3 shows a typical solid waste problem at Oluyole Estate Ibadan.

- b. An efficient waste management system including engineering landfills must be put in place against the backgrounds of the environmental circumstances of Ibadan. The poor waste management in the City may account for the situation that thirty one years after the "Omiyale" of 31st August 1980, a re-enactment of it occurred again on 26th August 2011 despite the channelization efforts of the Ogunpa. This is because government after government did not prioritize efficient solid waste management in the capital City, thereby facilitating flood disasters.

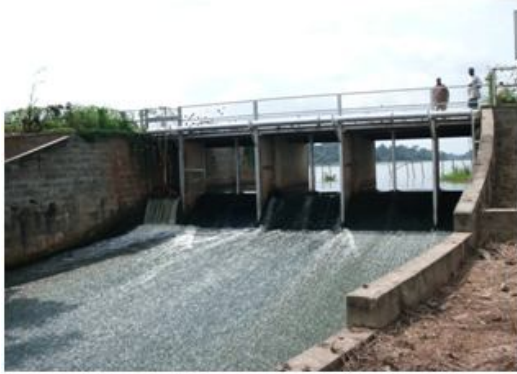
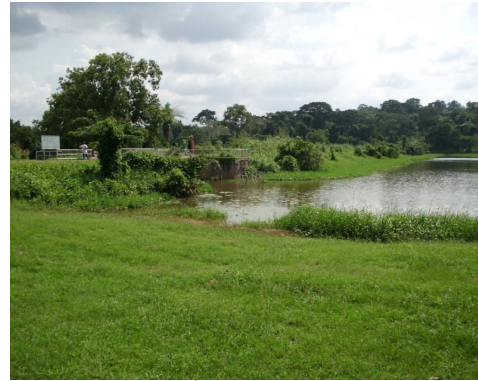
Fig. 4: The IITA Spillway and Dam Embankment after the Flood (7th September 2011)

Three dams were located within the upper catchment of the Ona River and the three dams were visited to determine how they had responded to the flood flow during the period. Table 1 is a summary of the team observations and figure 4 to figure 6 presents the conditions of the three dams after the flood.

Reservoir/Dam	Type	Level of Damage	Operating efficiency
IITA	Free flow	No damage to the dam. The spillway was found operating normally and has effectively discharged the excess flood to the downstream river channel without damage to the spillway or the immediate downstream channel. However, as a result of high winds that follow the rain storm, many trees were uprooted and many crops were damaged at some of experimental plots in the complex.	Said to be Okay
University of Ibadan	Free flow	Did not show any sign of stress as a result of the flood. The spillway was functioning normally and the downstream channel did not indicate an unusual flood	It was reported that the reservoir is silted up and its current capacity is not sufficient to meet the Institution water demand, hence supplementary supplies are received from the Eleyele reservoir.
Eleyele Reservoir/ Dam	Free flow	The dam was stable but the stilling basin and the downstream walls were damaged while the Waterworks was completely submerged as the water level downstream of the dam rose to about 2.4m above the channel floor. The station transformer, pump house, pumps, control panels and the clear water well were completely submerged for the duration of the flood event.	Restored to its original status

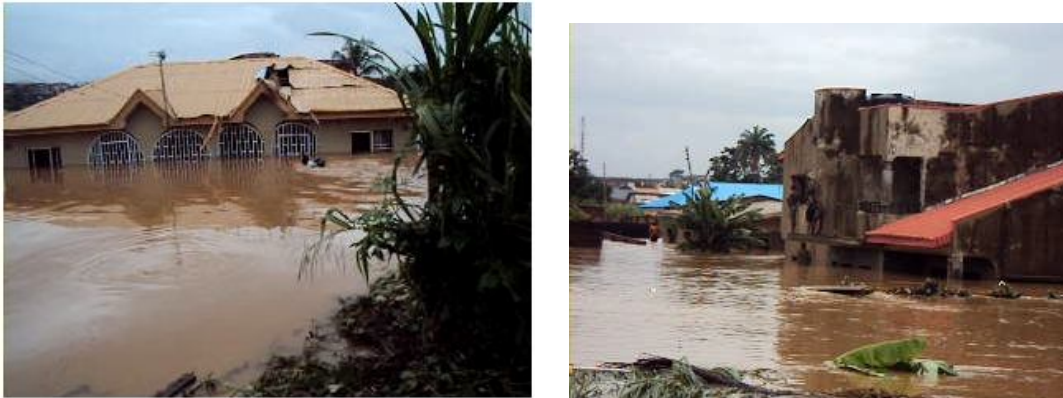
Fig. 7: Some cases of Property Submergence during the Flood

The flood wrecked havoc in the City particularly within the Ona River Basin. It washed off the Apete Bridge and overwhelms many bridges and culverts causing damages to the road and bridge / culvert structures at Ijokodo, Polytechnic road, Apata, Odo Ona Elewe and New

Garage, other place. Heap of garbage were seen deposited at the entrances of most of the bridges and culverts indicating that their capacities have been overwhelmed. Road pavements and the coal tar were peeled up and transported downstream thereby causing serious traffic disruptions. The Oluyole Power Holding Company of Nigeria (PHCN) substation, the fish ponds belonging to the Fisheries Department University of Ibadan, several residential houses were damaged and over 100 human lives were lost during the flood disaster. Figure 7 shows some of the properties damaged by the flood.
